U. S. NAVAL CIVIL ENGINEERING LABORATORY
Port Hueneme, California

Technical Note N-360

CORROSION STUDIES ASSOCIATED WITH AN AIR
BLAST CLOSURE UNIT

30 July 1959

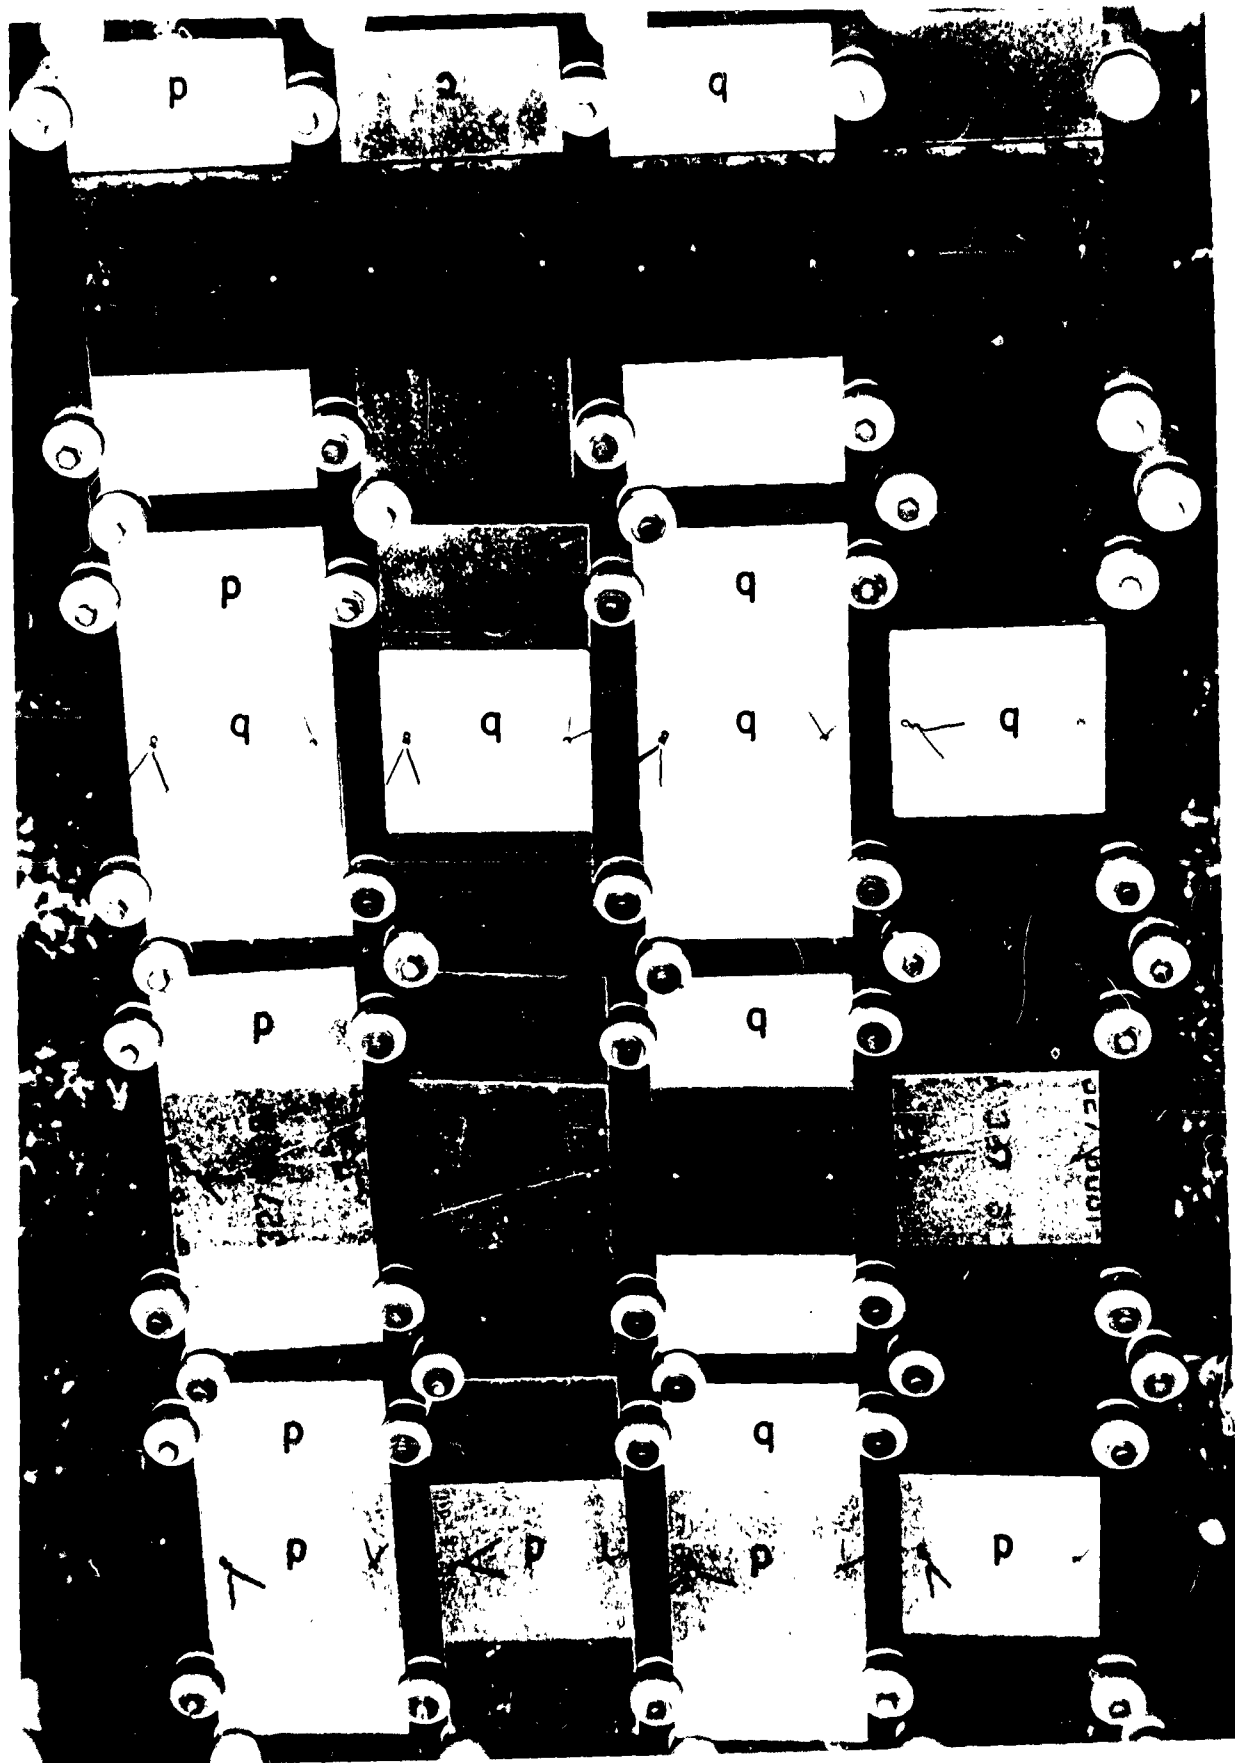
No corrosion was observed on the cadmium plated panels after three weeks exposure. Very slight general attack appeared on the 6061 aluminum alloy and slight pitting attack appeared on the 2024 aluminum alloy. The mild steel shows normal rust over the whole surface of the panel (Figure 8).

Examination of the edges of the smaller (4" x 4") panels at the point of contact with the larger panels showed that some corrosion products had formed between the iron to iron panels (Figure 8, a-a). No corrosion which can be attributed to metal to metal contact was observed at this time between the remaining pairs of metal panels.

Figure 8. Test panels after 3 month exposure. a - Mild steel; b - Cd plate; c - 6061 Al; d - 2024 Al.

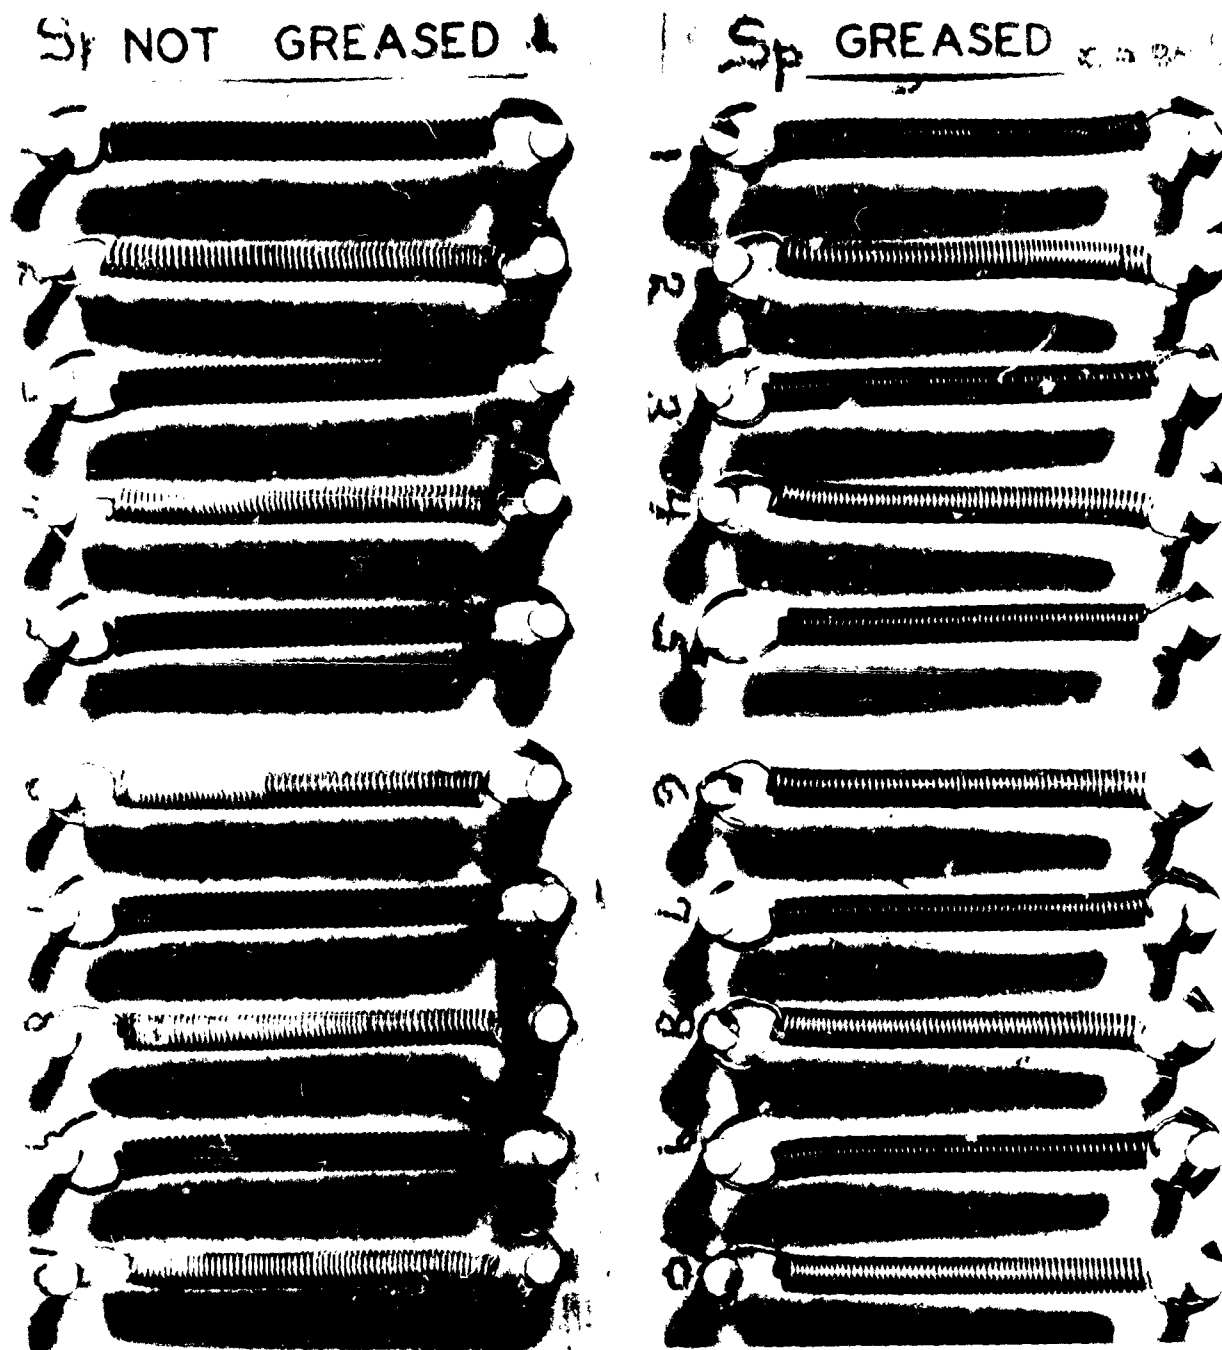
The condition of the test springs after three weeks of both unsheltered and sheltered exposure is shown in Figures 13, 14, and 15. Severe corrosion was observed on the bare steel springs in unsheltered exposure (Figure 13 - not greased - odd numbered). The corrosion of the springs in the sheltered exposure was considerably less (Figure 14). The bare steel springs containing the grease coating appeared to be protected satisfactorily in both types of exposure. Very slight corrosion attack was observed on the cadmium plated steel springs in unsheltered exposure (Figure 13 - not greased - even numbered), and no attack was observed on these springs in sheltered exposure (Figure 14). The greased cadmium springs showed no attack by corrosion in either type exposure.

Figure 13. Unsheltered test springs after 3 weeks exposure.

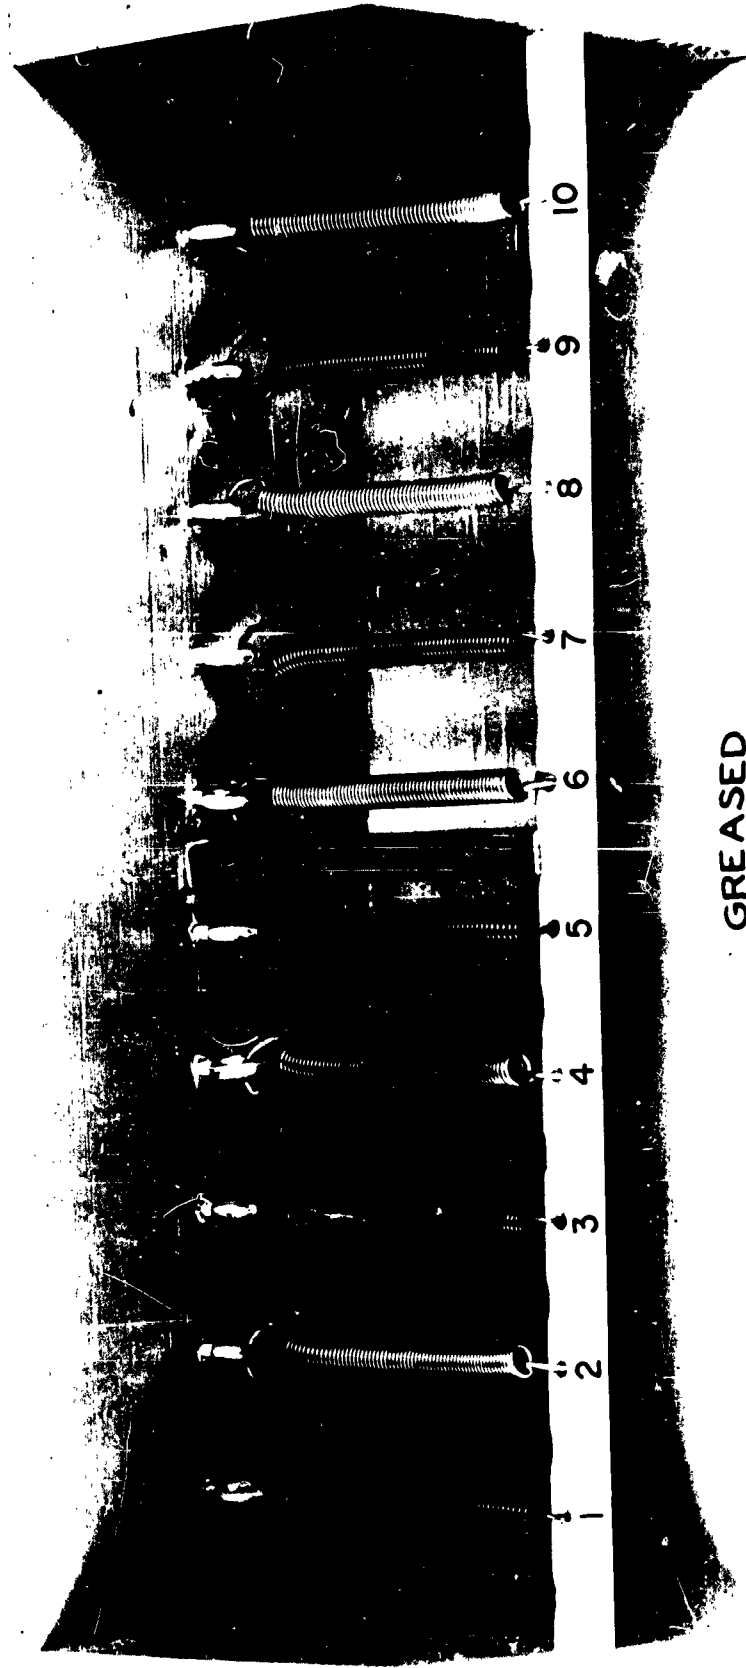
Figure 15. Sheltered test springs after 3 weeks exposure.

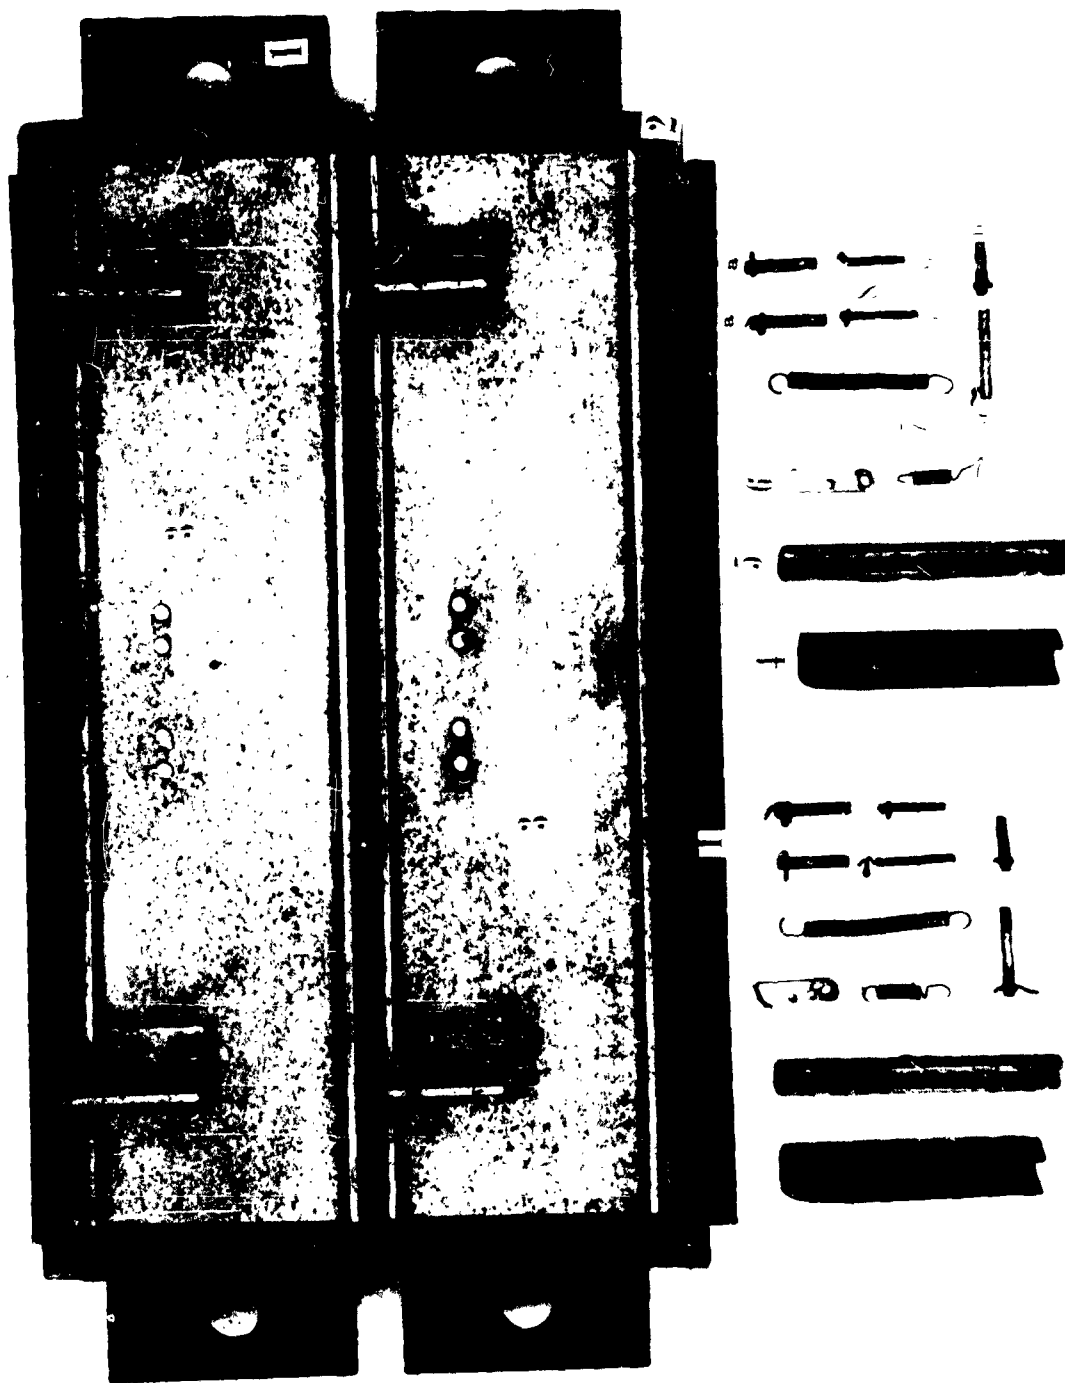
The foam gasketing material (2), Figures 16, 17, and 18, appeared to be a cellulose product and was in poor condition. After five months atmospheric exposure, a specimen of neoprene foamed rubber and a specimen

The 2024 aluminum alloy doors (3) showed very mild pitting over the entire surface, both on the inside and outside areas. These pits were covered with aluminum salts or corrosion products and were so shallow that their depth was not discernable with the eye. The strength of the louver doors would not be weakened as a result of this corrosion.

The 6061 aluminum alloy linkage (5) and lock or latch lever (6) were corroded in the same manner as the 2024 aluminum alloy doors. The larger pits on the linkage measured 0.0001 inch, but were only slightly discernable on the lock lever. The strength of the linkage and lock lever did not appear to be impaired.

The steel springs (7) were severely corroded. The spring tension was reduced to such an extent that the springs would not return to their original position after being very slightly extended.

The steel pins (8a), which were cadmium plated, were very slightly corroded. The steel pins (8b) containing no plating were corroded so badly that the lock lever (6) would not operate. The cadmium plated steel linkage (4) could be operated manually in either direction only with extreme difficulty. The unplated steel pins were reduced in diameter by approximately one-third by corrosion attack. Likewise, the steel cotter pins (9) and the unplated pins (8b) were cemented together by corrosion products so that the cotter pins could not be removed without breaking them apart.

Figure 16. Moving parts of Closure Unit after 11 months exposure, View 1.

1. Use neoprene foam rubber for the gasketing material (2), Figures 1, 2, and 3.
2. Fabricate the louver frame, (1) Figures 1, 2, and 3, and brackets (11a, 11b) Figures 3 and 21, from 6061 aluminum alloy.
3. All supporting pins (8) and cotter pins (9), Figures 16, 17 and 18, should be heavily cadmium plated (0.001 inch) and grease coated with an inhibited soft grease such as AN-C-124a, AM3 Type II.
4. All metal springs should be coated with an inhibited soft grease such as AN-C-124a, AM3 Type II.

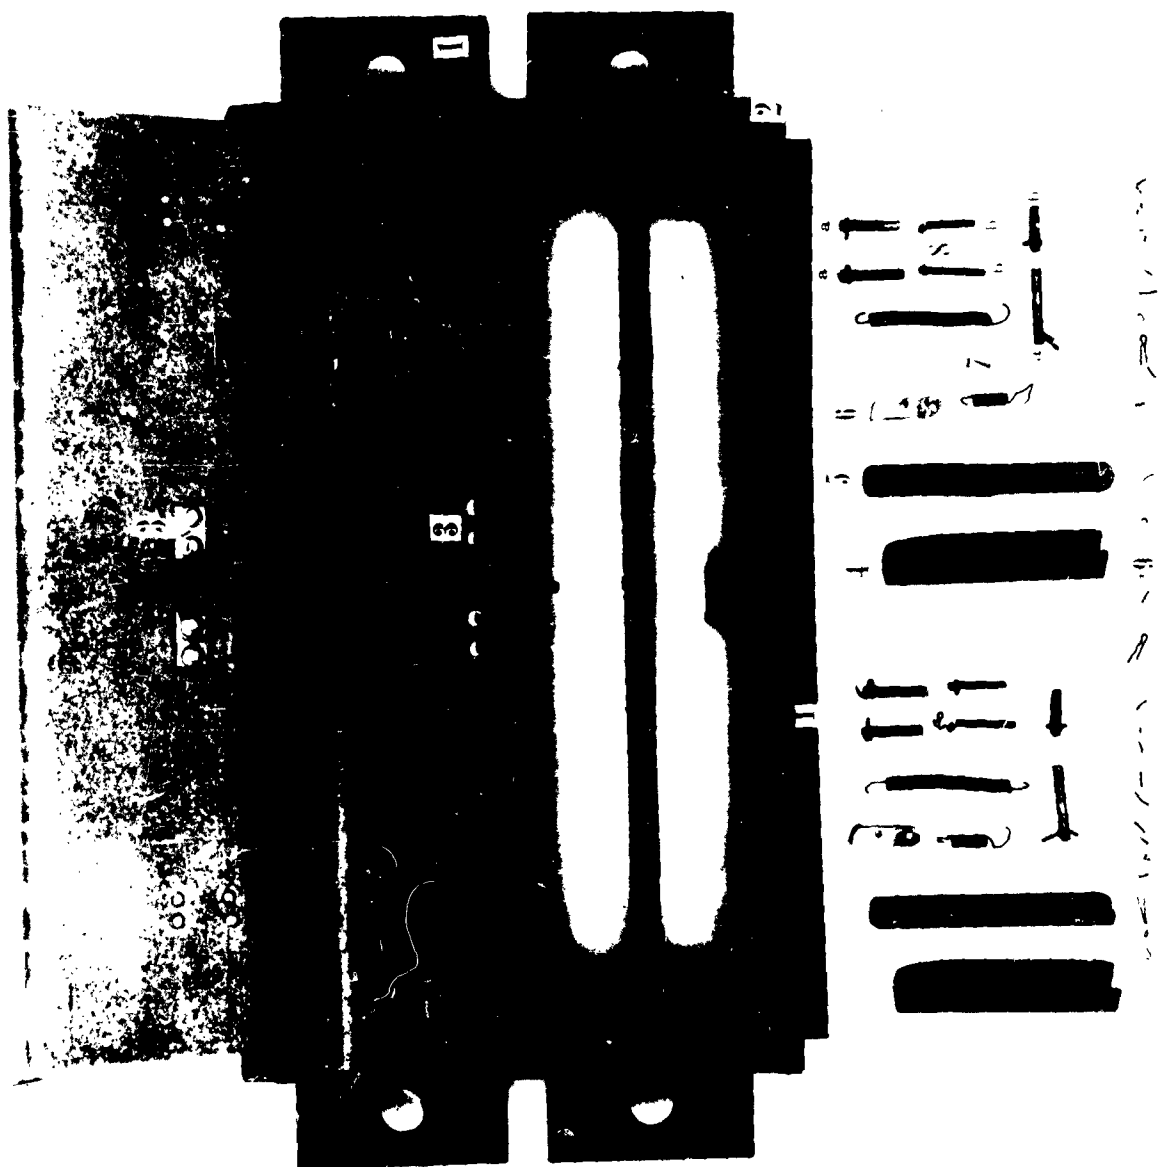
Figure 17. Moving parts of Closure Unit after 11 months exposure, View 2.

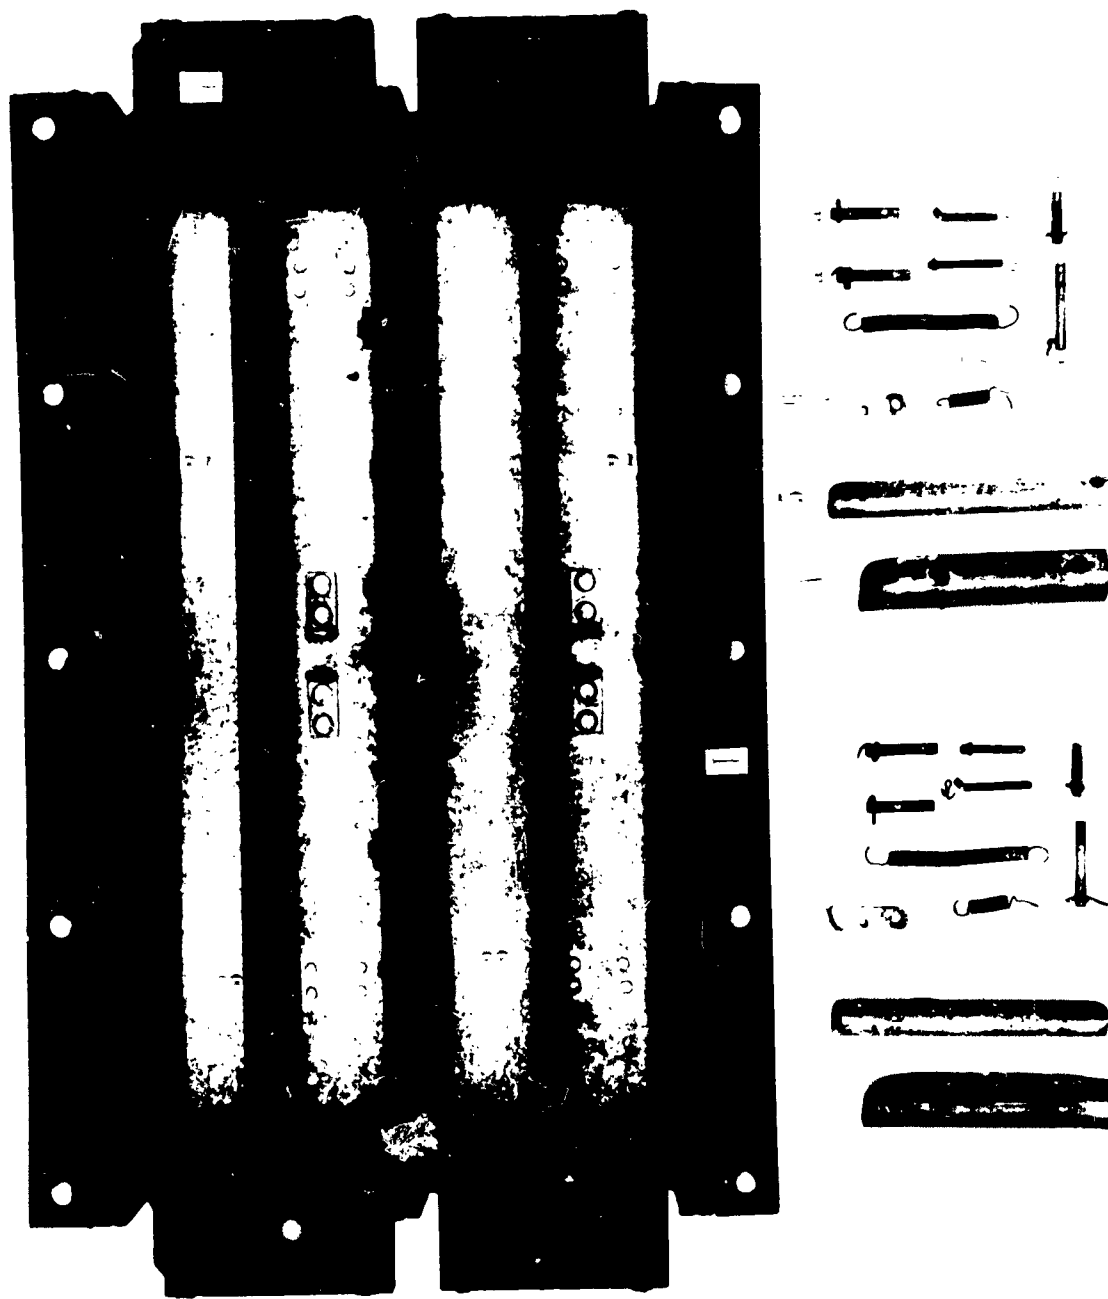
Figure 18. Moving parts of Closure Unit after 11 months exposure, View 3.

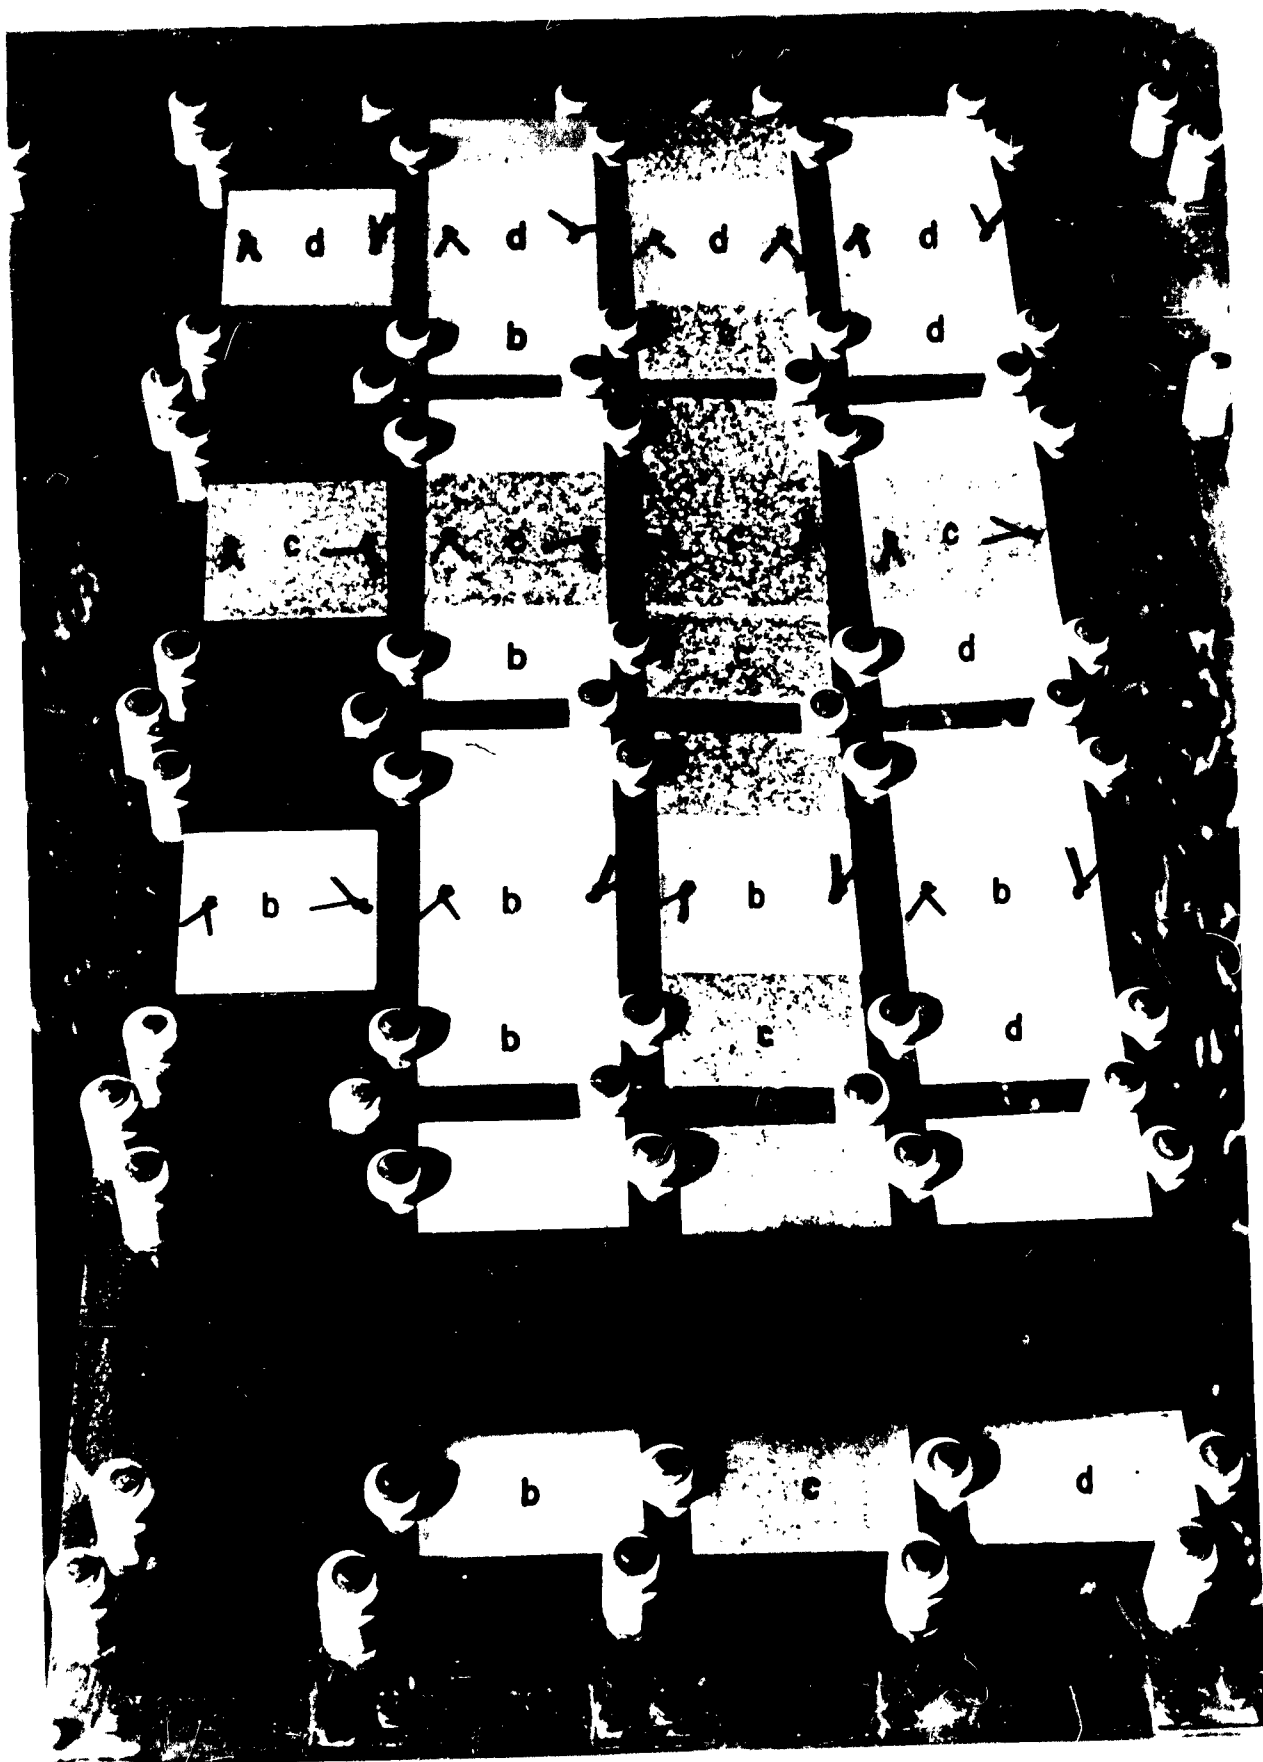
The corrosion on the specially prepared metal test panels, Figures 19 and 20, was of the same severity as that which occurred on similar

metal combinations of the closure unit. However, the contact between the large and small metal test panels did not result in increased corrosion products, and the small panel was easily lifted from the larger panel. Corrosion products were not sufficient in quantity to cause the two panels to become cemented together during the period of exposure (Figure 20). Possibly sufficient aeration was present to prevent a condition of prolonged dampness between the panels. As expected, the unplated steel panels (a) were severely corroded. The cadmium plated panels (b) were free of corrosion attack. The cadmium plating on the metal test panels measured 0.001 inches and is considered a heavy coating. The 6061 aluminum alloy (c) and the 2024 aluminum alloy (d), Figure 20, showed varying amounts of corrosion products over their entire surfaces. The quantity of corrosion products appeared to be slightly more on the 2024 aluminum alloy (d), than on the 6061 aluminum alloy (c). However, the pitting which occurred beneath the corrosion products appear to be insignificant in either case and was not measured.

In Figures 19 and 20 the cotter pins at the left (a) were cadmium plated and those on the right (b) were uncoated mild steel. The round steel pins which held the two metal panels together were cadmium plated and were not corroded. However, the steel cotter pins which were not cadmium plated (b) corroded so badly that they broke apart and could not be removed from the hole in the end of the round steel pins. The cadmium plated cotter pins (a) were corroded but could be loosened in the holes at the end of the round steel pins, yet they were sufficiently weakened by corrosion that they also broke apart upon being removed from the round steel pins.

Figure 19. Special test panels after 9 months exposure.
a- Mild steel; b- Cd plate; c- 6061 Al; d- 2024Al.
